DELAWARE RIVER BASIN,
TROUT BROOK, SUSSEX COUNTY,
NEW JERSEY.

LAKE PLYMOUTH DAM

(NJ 00818)

PHASE I INSPECTION REPORT.
NATIONAL DAM SAFETY PROGRAM

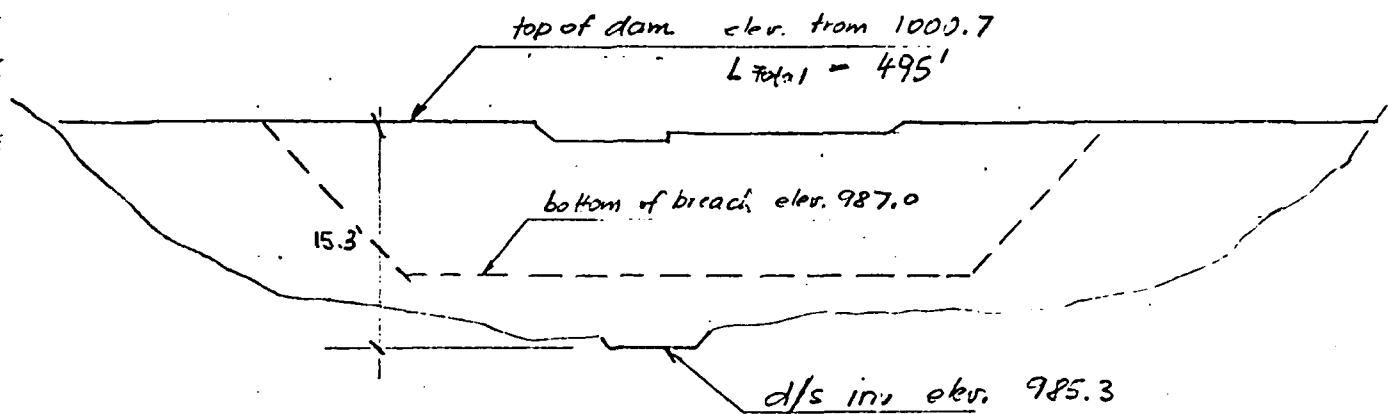
Bottom of breach effective width	= 150'
Bottom of breach elevation	= 987.0
Side slope of breach	= 1:1
Water surface elevation	= 998.0
Water surface elev. which will cause dam to fail	= 1000.7
Time for breach to develop max. size	= 1.0 Hr

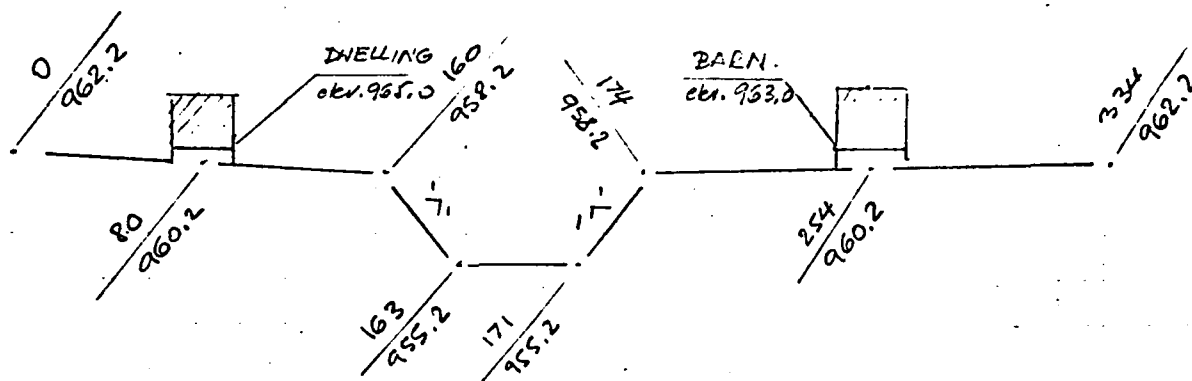
BREACH RESULTS

1. Peak outflow = 6593 [cfs]
